**Flood Control Project Maintenance
Levee Inspections**

Maintenance Issue Types Only, Levee Inspection Report By Mile - Spring 2017

Reclamation District No. 0900 West Sacramento

Waterway	Bank	Unit Miles	Inspection Start/End	Inspector
Unit No. 01 Sacramento River	Right	7.70	05/10/2017 05/10/2017	Pavel Kazi

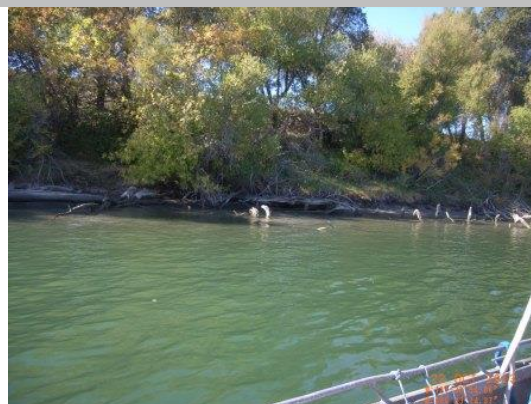
Photo 1 of 1 : SP_2017_RD0900_230_10_20170327_00008.jpg

LM Start	2.35	Rating **	M	Issue No.	10
LM End	2.47	Issue Type +	Ma	Location *	WS
Category	Supplemental			GPS Latitude/Longitude	
				Start	End
Item	2015 USACE Erosion Survey, DRAFT			38.554277 °	38.552504 °
				-121.515263 °	-121.514752 °
DWR ID	DWR_RD0900_01_s_2016_10				
Comment Code					
Inspector Comment					
2007 - Have good berm width with minor toe erosion. Close to the levee toe protection, but levee slope is steep. 2011 - New large erosion pocket. 2012 - Minor new erosion at the toe. 2015: No observed changes. [2015 Site ID: SAC_56-7_R]

USACE 2013 Photo #1

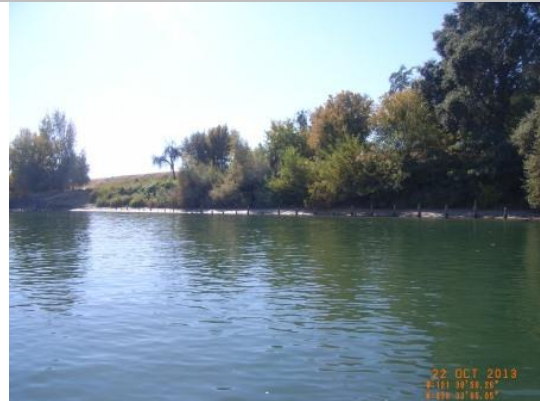
Photo 1 of 1 : SP_2017_RD0900_230_9_20170327_00007.jpg

LM Start	2.55	Rating **	M	Issue No.	9
LM End	2.64	Issue Type +	Ma	Location *	WS
Category	Supplemental			GPS Latitude/Longitude	
				Start	End
Item	2015 USACE Erosion Survey, DRAFT			38.551319 °	38.550090 °
				-121.514423 °	-121.513983 °
DWR ID	DWR_RD0900_01_s_2016_9				
Comment Code					
Inspector Comment					
1997 - Low berm is contributing to erosion. Old timber pile dikes above water parallel to bank. The upstream mitigation low berm causes a flow separation at the site. 1999 - Some new localized erosion with less than one foot of bank retreat. 2000 - Some new erosion at the upstream end. Fat toe deposits at toe. 2003 - Some new erosion upstream, but have a wide berm. 2011 - Minor new erosion at toe. 2015: No observed changes. [2015 Site ID: SAC_56-5_R]

USACE 2013 Photo #1

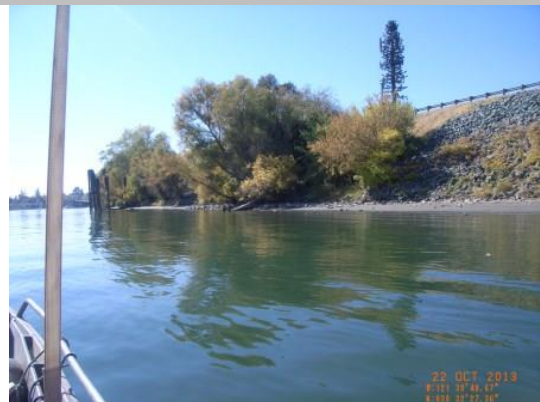
Photo 1 of 1 : SP_2017_RD0900_230_2_20170327_00002.jpg

LM Start	3.27	Rating **	M	Issue No.	2
LM End	3.48	Issue Type +	Ma	Location *	WS
Category	Supplemental			GPS Latitude/Longitude	
				Start	End
Item	2015 USACE Erosion Survey, DRAFT			38.541246 °	38.538689 °
				-121.513561 °	-121.515916 °
DWR ID	DWR_RD0900_01_s_2016_2				
Comment Code					
Inspector Comment					
2008 - Erosion into levee toe. Over steepened levee slope, worst at the upstream end. 2009 - Near vertical banks from rotational slumping, hidden by vegetation. 2010 - Boat sinking more, may be causing eddy scour around it. Difficult to see the vertical slumps due to dense vegetation. 2011 - Minor new erosion at the toe. The paddleboat that was sitting at this site for years has been removed. 2012 - Site extended upstream due to additional erosion. 2015: No observed changes. [2015 Site ID: SAC_55-7_R]

USACE 2013 Photo #1

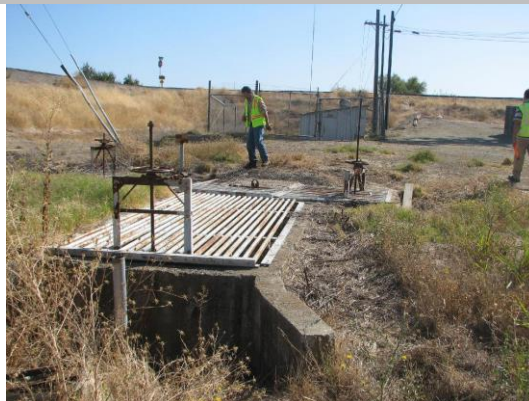
Photo 1 of 3 : UCIP_SP_2017_37668_68391.jpg

FS_ID:37668
DS_ID:17769
EP_NO: N/A
Repair Type: Non-Urgent
Crossing Status: Found
UCIP Comments: Dense vegetation limits the inspector's visibility to identify signs of pipe failure (leaks) along the slope. Recommend removing vegetation along pipe alignment to conduct proper inspection of structure and appurtenances.
FIELD_STRUCT_DESC: 24-inch pipe through the levee, 22.0 feet below the crown. Pump house at the landward toe. Screw gate in landside of the levee. As-built drawing available/found. As-built drawing# 6-13-1100 page 3, January 1933 and USGS River Mile 55.65 &M Manual Sac 116, Revision Year 2011
FS Date: 10/6/2009

View of concrete structure located on landward side.

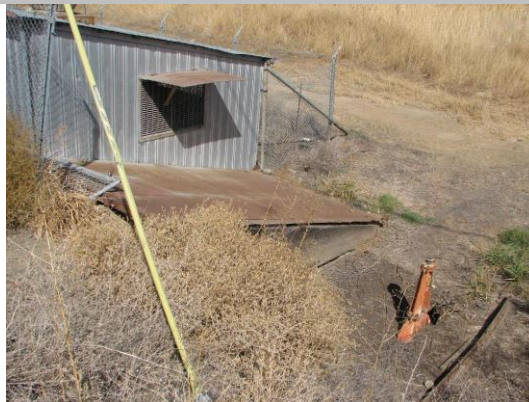
Photo 2 of 3 : UCIP_SP_2017_37668_68390.jpg

Pump house located on landward side.

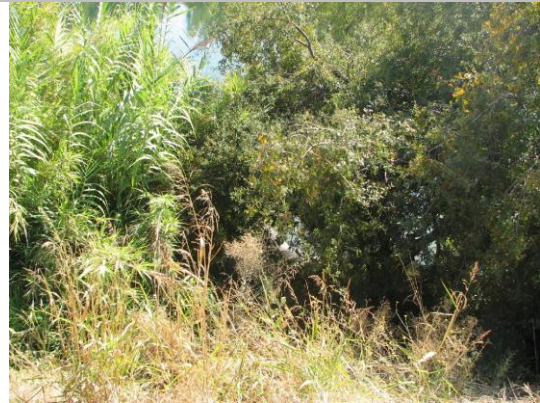
Photo 3 of 3 : UCIP_SP_2017_37668_68389.jpg

Item	DWR UCIP LMA Responsibility			38.540803 °	38.540803 °	
				-121.514255 °	-121.514255 °	
DWR ID						
Comment Code						
Inspector Comment						
FS_ID:37668						
DS_ID:17769						
EP_NO: N/A						
Repair Type: Non-Urgent						
Crossing Status: Found						
UCIP Comments: Dense vegetation limits the inspector's visibility to identify signs of pipe failure (leaks) along the slope. Recommend removing vegetation along pipe alignment to conduct proper inspection of structure and appurtenances.						
FIELD_STRUCT_DESC: 24-inch pipe through the levee, 22.0 feet below the crown. Pump house at the landward toe. Screw gate in landside of the levee. As-built drawing available/found. As-built drawing# 6-13-1100 page 3, January 1933 and USGS River Mile 55.65 &M Manual Sac 116, Revision Year 2011						
FS Date: 10/6/2009

Pipe visible on waterward side visible through dense vegetation.

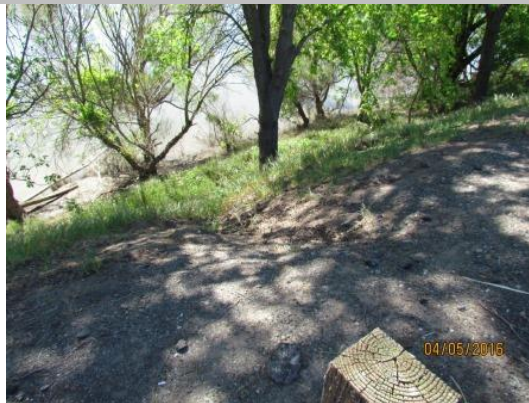
Photo 1 of 2 : SP_2017_RD0900_230_4_20170327_00003.jpg

LM Start	3.41	Rating **	M	Issue No.	4
LM End	3.41	Issue Type +	Ma	Location *	WS
Category	Earthen Levee			GPS Latitude/Longitude	
				Start	End
Item	Slope Stability			38.539770 °	38.539770 °
				-121.515276 °	-121.515276 °
DWR ID	DWR_RD0900_01_s_2014_4				
Comment Code					
S2 : Repair the levee slope damaged by foot traffic and prevent access where possible.					
Inspector Comment

Updated picture of the slope instability on the waterside of the levee looking downstream during spring 2016 inspection.

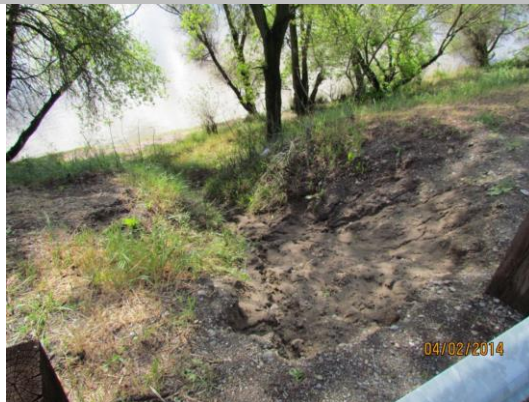
Photo 2 of 2 : SP_2017_RD0900_230_4_20170327_00004.jpg

A slope instability was found on the waterside slope of the levee looking downstream.

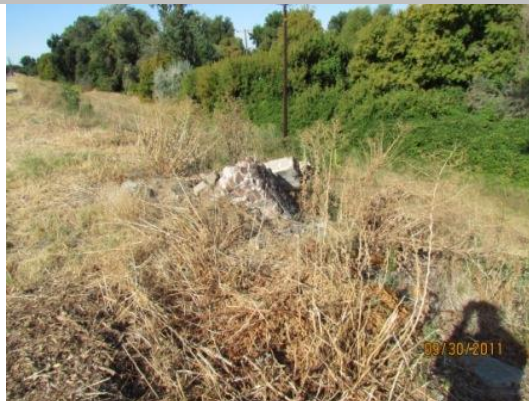
Photo 1 of 1 : SP_2017_RD0900_230_327_20170327_00019.jpg

LM Start	4.04	Rating **	M	Issue No.	327
LM End	4.04	Issue Type +	Ma	Location *	LS
Category	Earthen Levee			GPS Latitude/Longitude	
				Start	End
Item	Encroachments			38.534759 °	38.534759 °
				-121.524902 °	-121.524902 °
DWR ID	DWR_RD0900_01_s_2012_327				
Comment Code					
DE : Debris					
Inspector Comment

Concrete debris were found on the landside of the levee looking upstream.

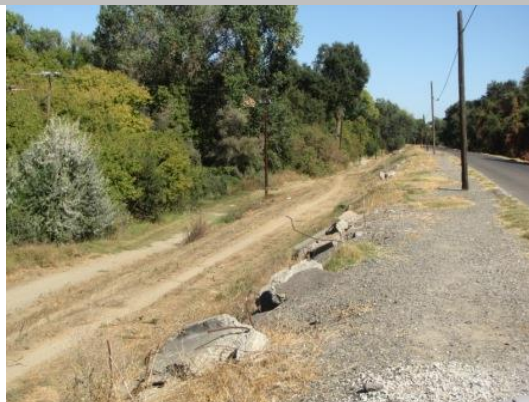
Photo 1 of 1 : SP_2017_RD0900_230_54_20170327_00014.jpg

LM Start	4.10	Rating **	M	Issue No.	54
LM End	4.10	Issue Type +	Ma	Location *	LS
Category	Earthen Levee			GPS Latitude/Longitude	
				Start	End
Item	Encroachments			38.534364 °	38.534364 °
				-121.526051 °	-121.526051 °
DWR ID	DWR_RD0900_01_s_2012_54				
Comment Code					
DE : Debris					
Inspector Comment					
Concrete debris with metal posing a safety risk.

View of concrete debris with metal looking upstream.

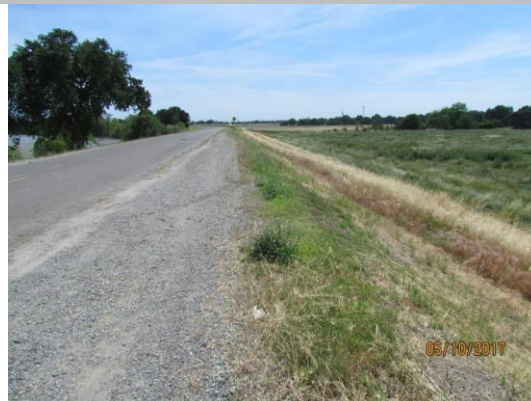
Photo 1 of 1 : SP_2017_RD0900_230_63_20170511_00031.jpg

LM Start	4.50	Rating **	M	Issue No.	63
LM End	7.04	Issue Type +	Ma	Location *	LS
Category	Earthen Levee			GPS Latitude/Longitude	
				Start	End
Item	Vegetation			38.530837 °	38.513372 °
				-121.531774 °	-121.554450 °
DWR ID	DWR_RD0900_01_s_2017_63				
Comment Code					
V1 : Control annual grass and weeds on the levee slopes and easements.					
Inspector Comment

View of vegetation on the landside of the levee.

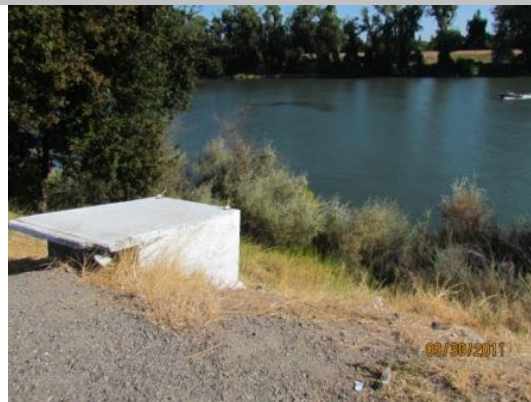
Photo 1 of 1 : SP_2017_RD0900_230_330_20170327_00020.jpg

LM Start	4.95	Rating **	M	Issue No.	330
LM End	4.95	Issue Type +	Ma	Location *	WS
Category	Earthen Levee			GPS Latitude/Longitude	
				Start	End
Item	Encroachments			38.524898 °	38.524898 °
				-121.529674 °	-121.529674 °
DWR ID	DWR_RD0900_01_s_2012_330				
Comment Code					
DE : Debris					
Inspector Comment

Concrete anchor was found on the waterside slope of the levee looking upstream.

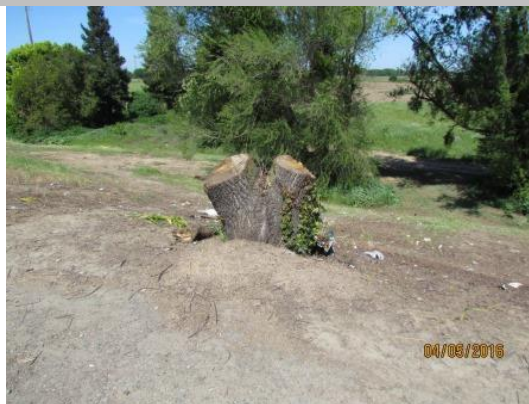
Photo 1 of 1 : SP_2017_RD0900_230_64_20170327_00018.jpg

LM Start	5.57	Rating **	N	Issue No.	64
LM End	5.57	Issue Type +	Ma	Location *	LS
Category	Earthen Levee			GPS Latitude/Longitude	
				Start	End
Item	Trim / Thin Trees			38.518654 °	38.518654 °
				-121.528685 °	-121.528685 °
DWR ID	DWR_RD0900_01_s_2016_64				
Comment Code					
T5 : Tree stumps.					
Inspector Comment

View of a tree stump on the landside of the levee looking downstream.

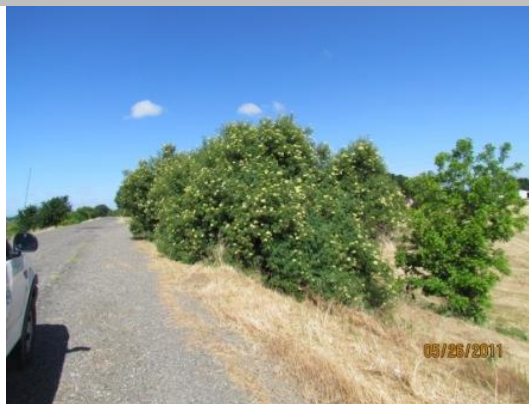
Photo 1 of 1 : SP_2017_RD0900_230_25_20170327_00013.jpg

LM Start	5.95	Rating **	M	Issue No.	25
LM End	5.96	Issue Type +	Ma	Location *	LS
Category	Earthen Levee			GPS Latitude/Longitude	
				Start	End
Item	Vegetation			38.517952 °	38.517948 °
				-121.535672 °	-121.535857 °
DWR ID	DWR_RD0900_01_s_2012_25				
Comment Code					
V4 : Elderberries are blocking visibility and flood fight capability.					
Inspector Comment					
Elderberries are partially blocking the visibility.

Elderberry located on the landside of the levee obstructing the view. The picture was taken from the crown looking downstream.

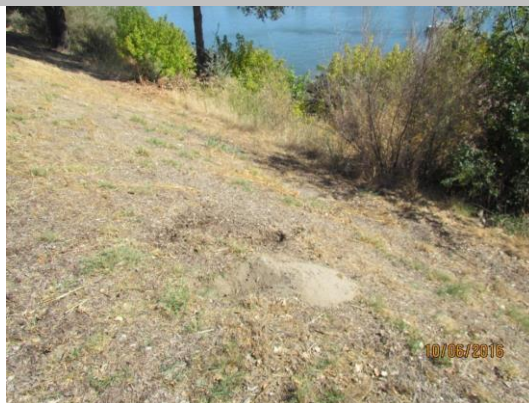
Photo 1 of 1 : SP_2017_RD0900_230_62_20170327_00017.jpg

LM Start	6.87	Rating **	M	Issue No.	62
LM End	6.87	Issue Type +	Ma	Location *	WS
Category	Earthen Levee			GPS Latitude/Longitude	
				Start	End
Item	Animal Control			38.514974 °	38.514974 °
				-121.552041 °	-121.552041 °
DWR ID	DWR_RD0900_01_f_2016_62				
Comment Code					
A3 : No rodents visible, but rodent burrows visible; need to backfill and compact or grout burrows.					
Inspector Comment

View of a rodent hole on the waterside of the levee.

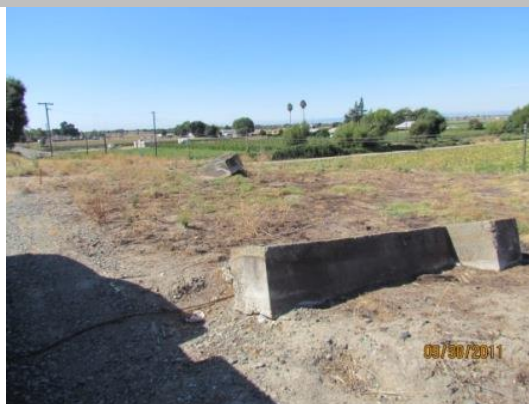
Photo 1 of 1 : SP_2017_RD0900_230_343_20170327_00023.jpg

LM Start	7.10	Rating **	M	Issue No.	343	
LM End	7.10	Issue Type +	Ma	Location *	LS	
Category	Earthen Levee			GPS Latitude/Longitude		
				Start		End
Item	Encroachments			38.512642 °	38.512642 °	
				-121.554881 °	-121.554881 °	
DWR ID	DWR_RD0900_01_s_2012_343					
Comment Code						
DE : Debris						
Inspector Comment						
Concrete debris from old railroad track.

Concrete debris from old rail road track was found on the landside of the levee looking upstream.

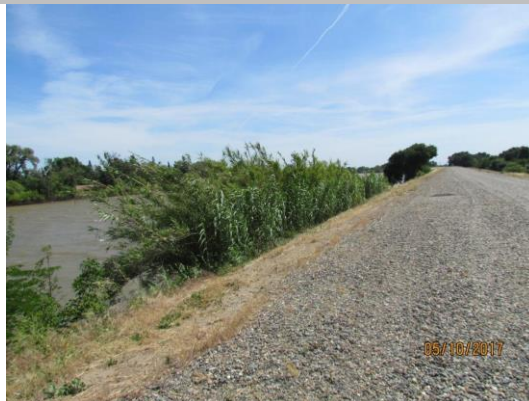
Photo 1 of 1 : SP_2017_RD0900_230_59_20170511_00032.jpg

LM Start	7.47	Rating **	M	Issue No.	59
LM End	7.47	Issue Type +	Ma	Location *	WS
Category	Earthen Levee			GPS Latitude/Longitude	
				Start	End
Item	Vegetation			38.507648 °	38.507648 °
				-121.557571 °	-121.557571 °
DWR ID	DWR_RD0900_01_f_2012_59				
Comment Code					
V2 : Remove the wild growth other than native grasses from the levee slopes.					
Inspector Comment					
Arrundo growth on the waterside slope of the levee.

View of the arundo on the waterside of the levee during spring 2017 inspection.

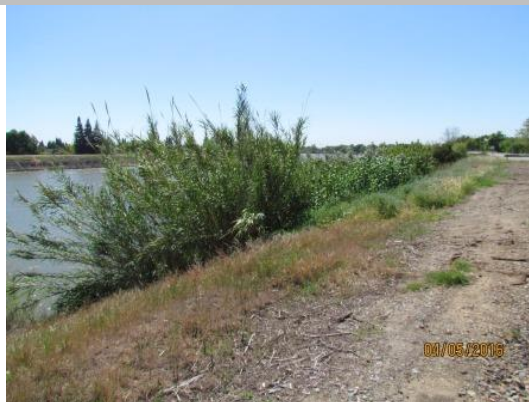
Photo 1 of 2 : SP_2017_RD0900_230_15_20170327_00009.jpg

LM Start	7.78	Rating **	M	Issue No.	15
LM End	7.78	Issue Type +	Ma	Location *	WS
Category	Earthen Levee			GPS Latitude/Longitude	
				Start	End
Item	Vegetation			38.503490 °	38.503490 °
				-121.559770 °	-121.559770 °
DWR ID	DWR_RD0900_01_f_2013_15				
Comment Code					
V2 : Remove the wild growth other than native grasses from the levee slopes.					
Inspector Comment					
Arrundo on the waterside

Updated picture of the arundo on the waterside of the levee during spring 2016 inspection.

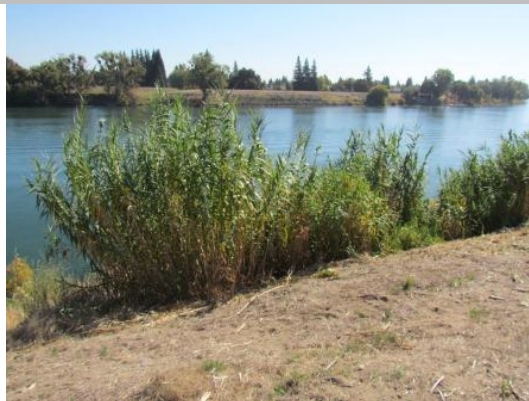
Photo 2 of 2 : SP_2017_RD0900_230_15_20170327_00010.jpg

LM Start	7.78	Rating **	M	Issue No.	15 (cont)	
LM End	7.78	Issue Type +	Ma	Location *	WS	
Category	Earthen Levee			GPS Latitude/Longitude		
				Start		End
Item	Vegetation			38.503490 °		38.503490 °
				-121.559770 °		-121.559770 °
DWR ID	DWR_RD0900_01_f_2013_15					
Comment Code						
V2 : Remove the wild growth other than native grasses from the levee slopes.						
Inspector Comment						
Arrundo on the waterside

View of arundo on the waterside of the levee looking downstream.

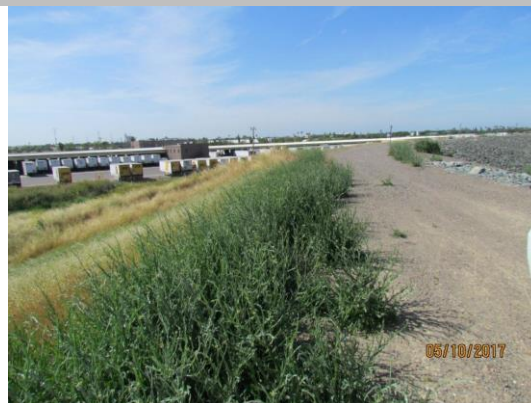
Photo 1 of 1 : SP_2017_RD0900_231_40_20170511_00043.jpg

View of the vegetation on the landside of the levee. Spring 2017

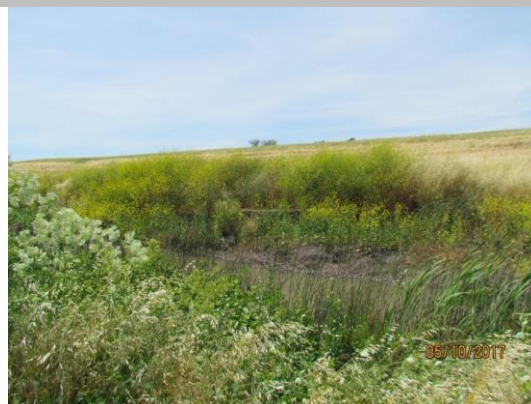
Photo 1 of 2 : SP_2017_RD0900_231_42_20170511_00047.jpg

LM Start	3.25	Rating **	M	Issue No.	42
LM End	4.68	Issue Type +	Ma	Location *	LS
Category	Earthen Levee			GPS Latitude/Longitude	
				Start	End
Item	Erosion / Bank Caving			38.541139 °	38.520300 °
				-121.582220 °	-121.582140 °
DWR ID	DWR_RD0900_02_s_2017_42				
Comment Code					
E1 : Note and monitor erosion site.					
Inspector Comment					
Landside levee toe road approximately 15 feet wide, and some part landside levee toe is eroded due to the recent 2017 storm.

View of an erosion on the landside toe of the levee at levee mile 3.98.

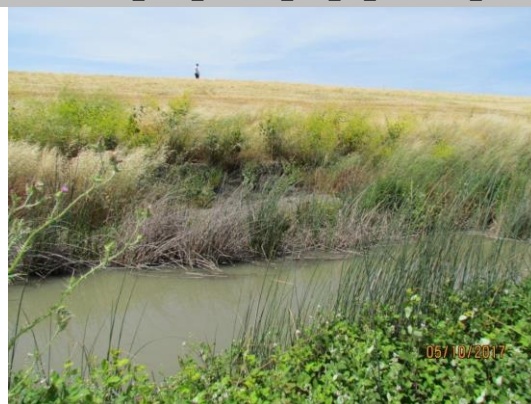
Photo 2 of 2 : SP_2017_RD0900_231_42_20170511_00048.jpg

View of an erosion on the landside toe of the levee at levee mile 3.92.

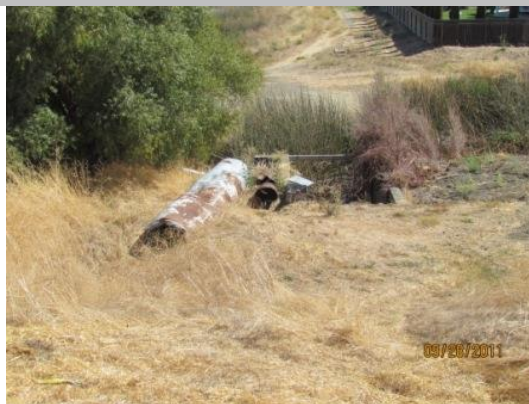
Photo 1 of 1 : SP_2017_RD0900_231_15_20170327_00002.jpg

Abandon pipes and debris was found on the landside of the levee looking upstream.

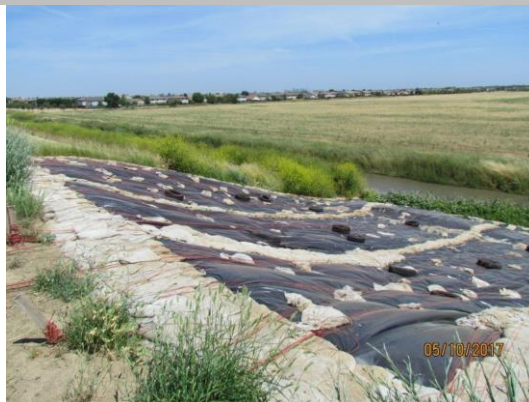
Photo 1 of 1 : SP_2017_RD0900_231_43_20170511_00046.jpg

LM Start	4.63	Rating **	M	Issue No.	43
LM End	4.63	Issue Type +	Ma	Location *	LS
Category	Earthen Levee			GPS Latitude/Longitude	
				Start	End
Item	Slope Stability			38.521110 °	38.521110 °
				-121.582148 °	-121.582148 °
DWR ID	DWR_RD0900_02_s_2017_43				
Comment Code					
S1 : Repair slope instability.					
Inspector Comment					
LMA placed a raincoat over a slope instability issue. The LMA is planning on repairing the site soon.

View of a slope instability covered by raincoat on the landside slope of the levee looking upstream. Spring 2017

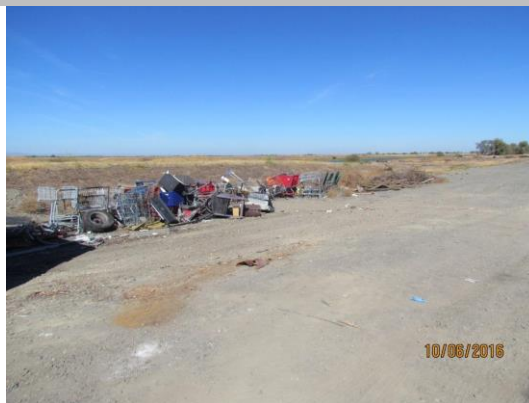
Photo 1 of 1 : SP_2017_RD0900_231_45_20170327_00003.jpg

View of debris on the landside shoulder of the levee looking upstream.

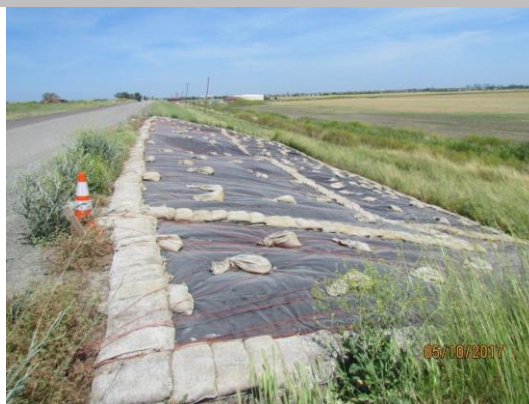
Photo 1 of 2 : SP_2017_RD0900_231_41_20170511_00044.jpg

LM Start	5.26	Rating **	M	Issue No.	41
LM End	5.26	Issue Type +	Ma	Location *	WS
Category	Earthen Levee			GPS Latitude/Longitude	
				Start	End
Item	Slope Stability			38.511915 °	38.511915 °
				-121.582167 °	-121.582167 °
DWR ID	DWR_RD0900_02_s_2017_41				
Comment Code					
S1 : Repair slope instability.					
Inspector Comment					
The LMA placed a raincoat over a slope instability. They are planning on repairing the site soon.

View of a slope instability covered by a raincoat on the landside of the levee looking upstream. Spring 2017

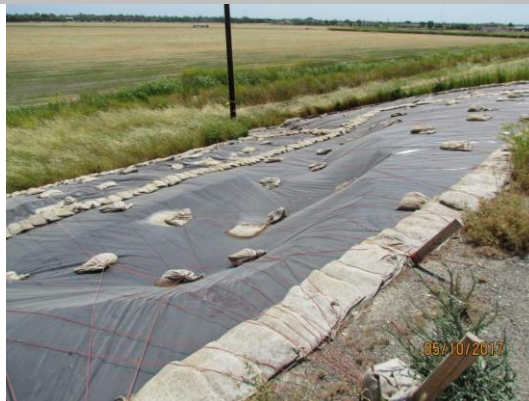
Photo 2 of 2 : SP_2017_RD0900_231_41_20170511_00045.jpg

LM Start	5.26	Rating **	M	Issue No.	41 (cont)	
LM End	5.26	Issue Type +	Ma	Location *	WS	
Category	Earthen Levee			GPS Latitude/Longitude		
				Start		End
Item	Slope Stability			38.511915 °		38.511915 °
				-121.582167 °		-121.582167 °
DWR ID	DWR_RD0900_02_s_2017_41					
Comment Code						
S1 : Repair slope instability.						
Inspector Comment						
The LMA placed a raincoat over a slope instability. They are planning on repairing the site soon.

An alternate view of the slope instability on the landside of the levee looking downstream. Spring 2017
